Report No.:101891909GRR-001  
Page 1 of 17

**Test Report For:**  
**SUDEX ARGENTINA SRL**  
**ANSI/BIFMA X5.1-2011**  
**CHAIR TEST STANDARD**  
**Foldi Arm Chair**

Part Description: Foldi Arm Chair  
Condition of Test Sample: New

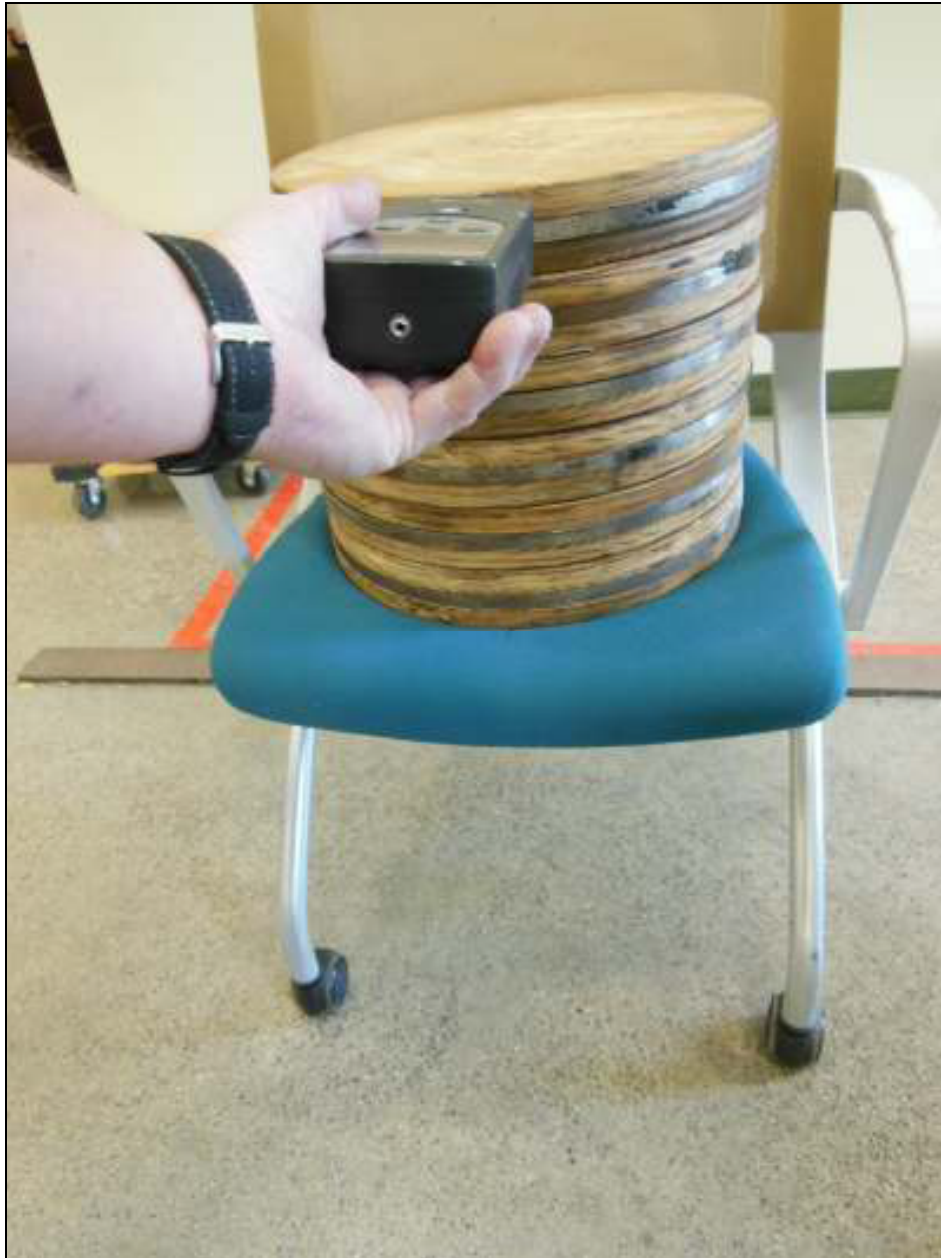
**Stability Test - Rear**

(Rear Stability Only):  
Type I: 286 lbs. (13 disks)  
Type II: 286 lbs (13 disks)  
Type III: 132 lbs (6 disks)

Rear Stability: The force to tip shall not be less than:

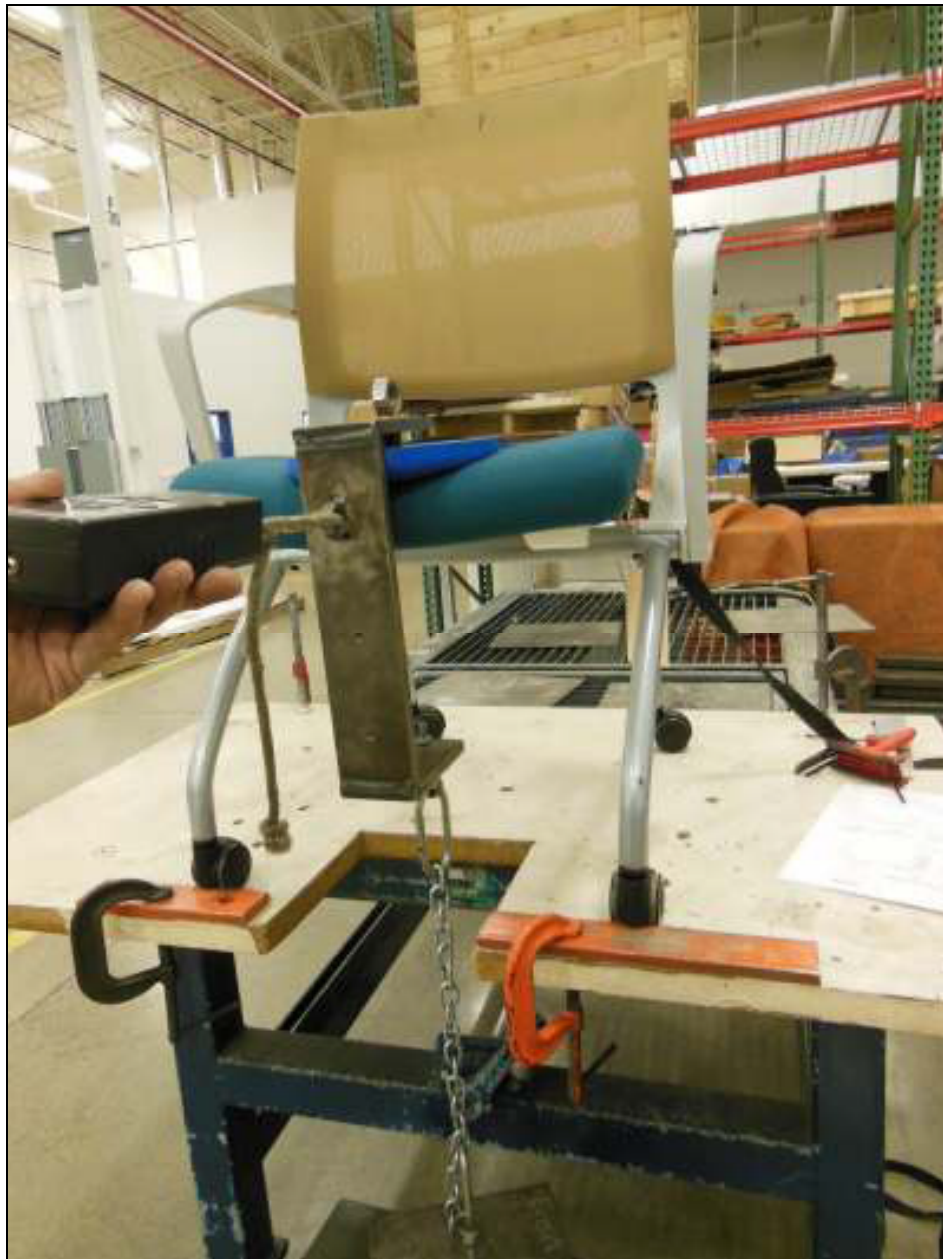
**Stability Test - Front**

Alternative: N/A  
Vertical Load: 135 Lbs  
Horizontal Force: 4.5 Lbs  
Number of Samples Tested: One (1)

Front Stability: The chair shall not tip over as the result of the force application of 4.5 lbf.

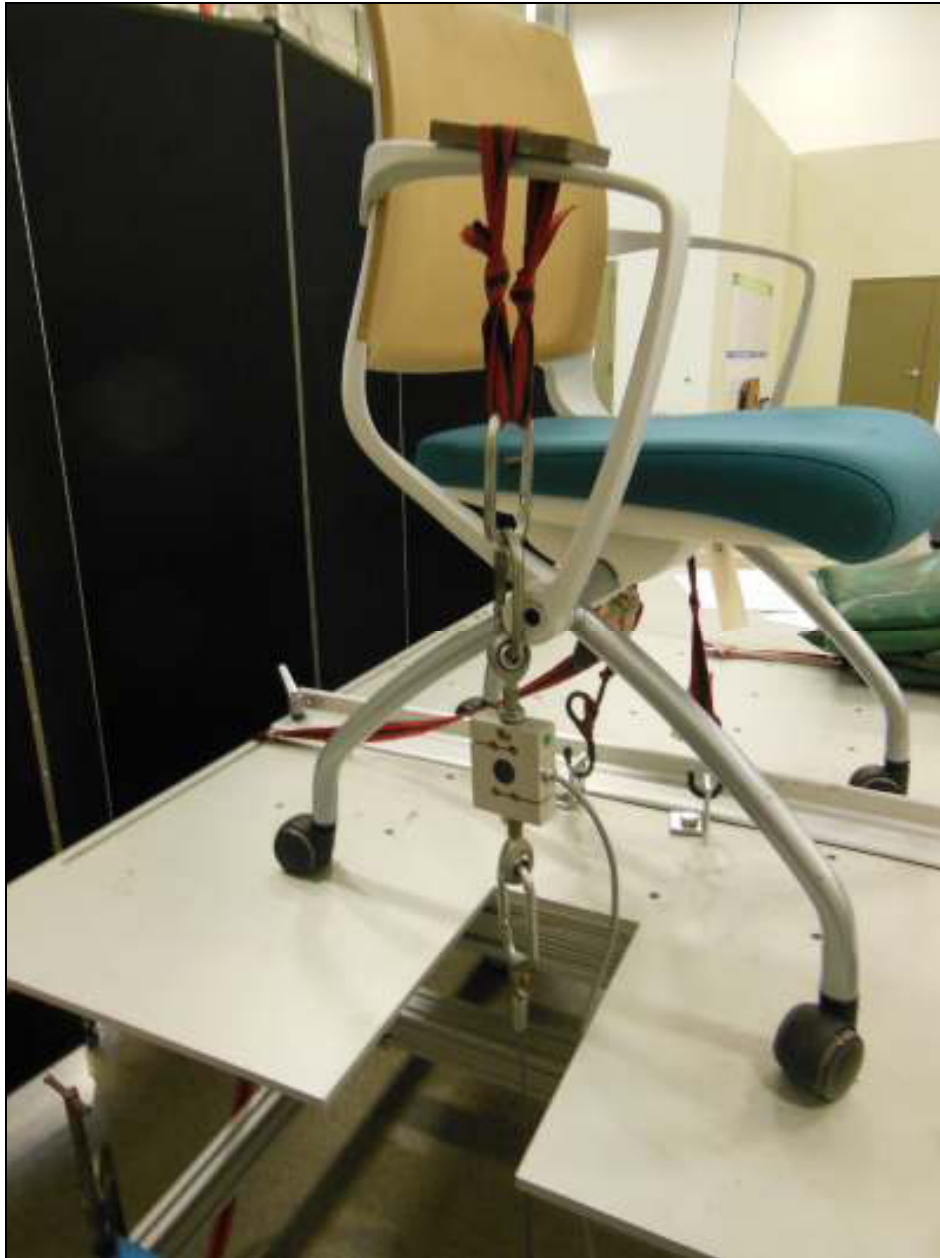
**Arm Strength Test Vertical-Static**

Test Method: ANSI/BIFMA X5.1-2011; Test No. 13  
Functional Static Load: 169 lbf.  
Proof Static Load: 253 lbf.  
Number of Samples Tested: One (1)

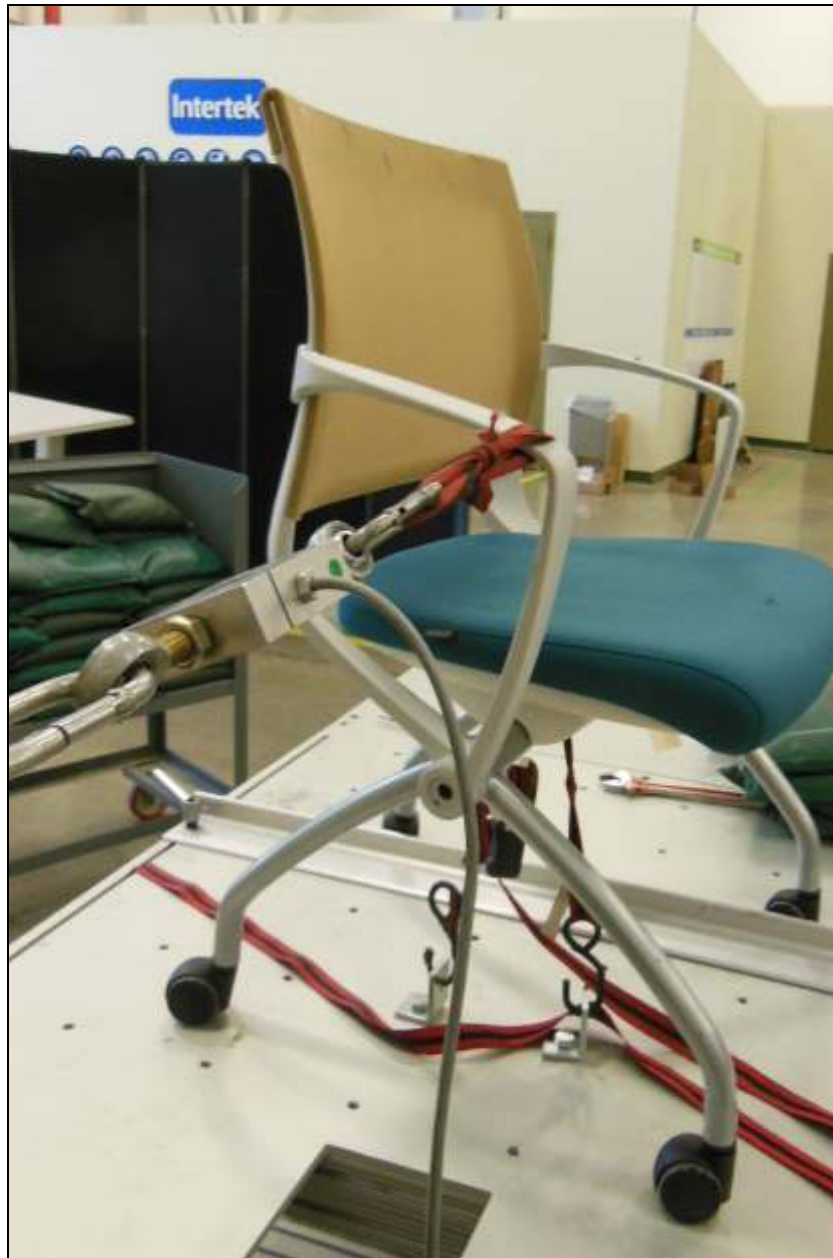
**Arm Strength Test- Horizontal-Static**

Test Method: ANSI/BIFMA X5.1-2011; Test No. 14  
Functional Force: 100 lbf.  
Proof Load: 150 lbf.  
Number of Samples Tested: One (1)

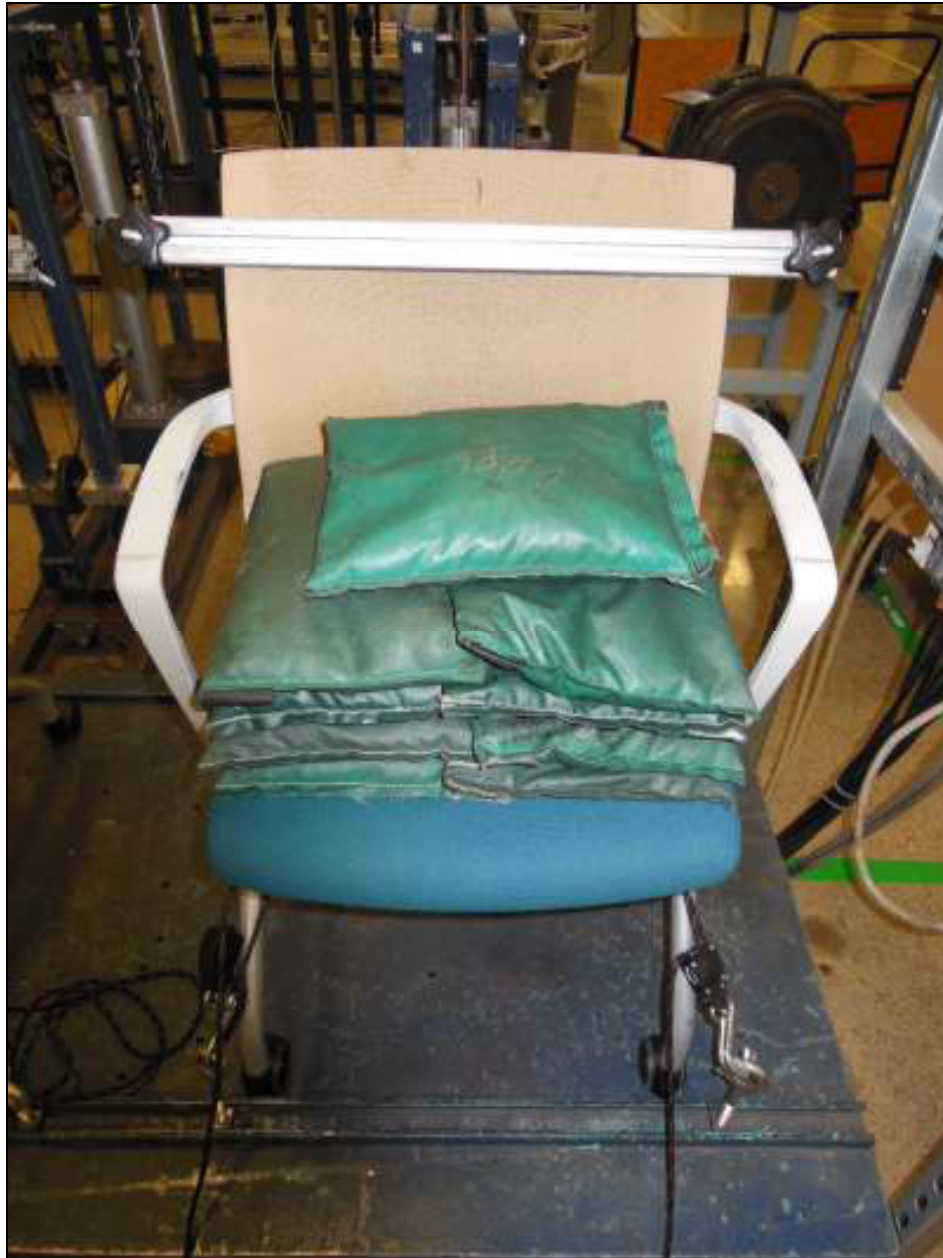
**BACK DURABILITY TEST-CYCLIC**

Test Method: ANSI/BIFMA X5.1-2011; Test No. 16  
Backrest Width: 18"  
Number of Cycles Required: 120,000  
Center Pull Location: 80,000  
Off Center Pull Location: 40,000  
Force Applied to Chair Back: 75 lbf.  
Load in Seat: 225 lbs.  
Cycles per Minute: 10 to 30

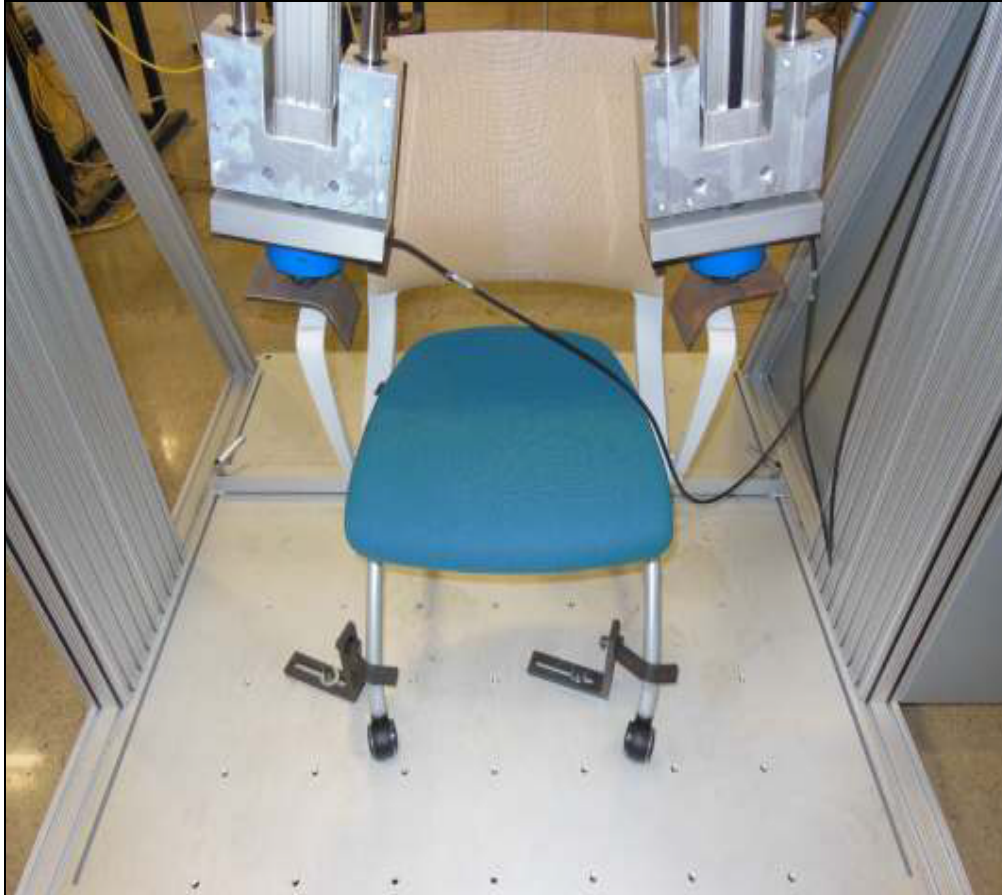
**Arm Durability Test – Cyclic**

Test Method: ANSI/BIFMA X5.1-2011; Test No. 21  
Load To Each Arm: 90 lbs.  
Angle of Force: 10 Degrees from Vertical  
Number of Cycles Required: 60,000  
Cycles per Minute: 10 to 30  
Number of Samples Tested: One (1)
